Subj: Report of independent investigation of major aircraft accident involving R7V-1 Bu. No. 128441 on 31 October 1954.

1. R7V-1 BUNO 128441 assigned to AIR TRANSPORT SQUADRON ONE (VR-1) was reported missing and presumed lost at sea at 0815 EST on 31 October 1954 while on a regularly scheduled flight from NAS Patuxent River, Maryland to Lajes Airport, the Azores. The planned route for the flight was the great circle course between Shad Intersection (LAT 37-40N; LONG 73-00W) and Lajes Airport, the Azores. There were forty-two (42) persons on board the aircraft at the time of the accident and all are missing and presumed lost at sea. There was no damage to private property as a result of this accident. The mission of the flight was regularly-scheduled Fleet Logistic Support.

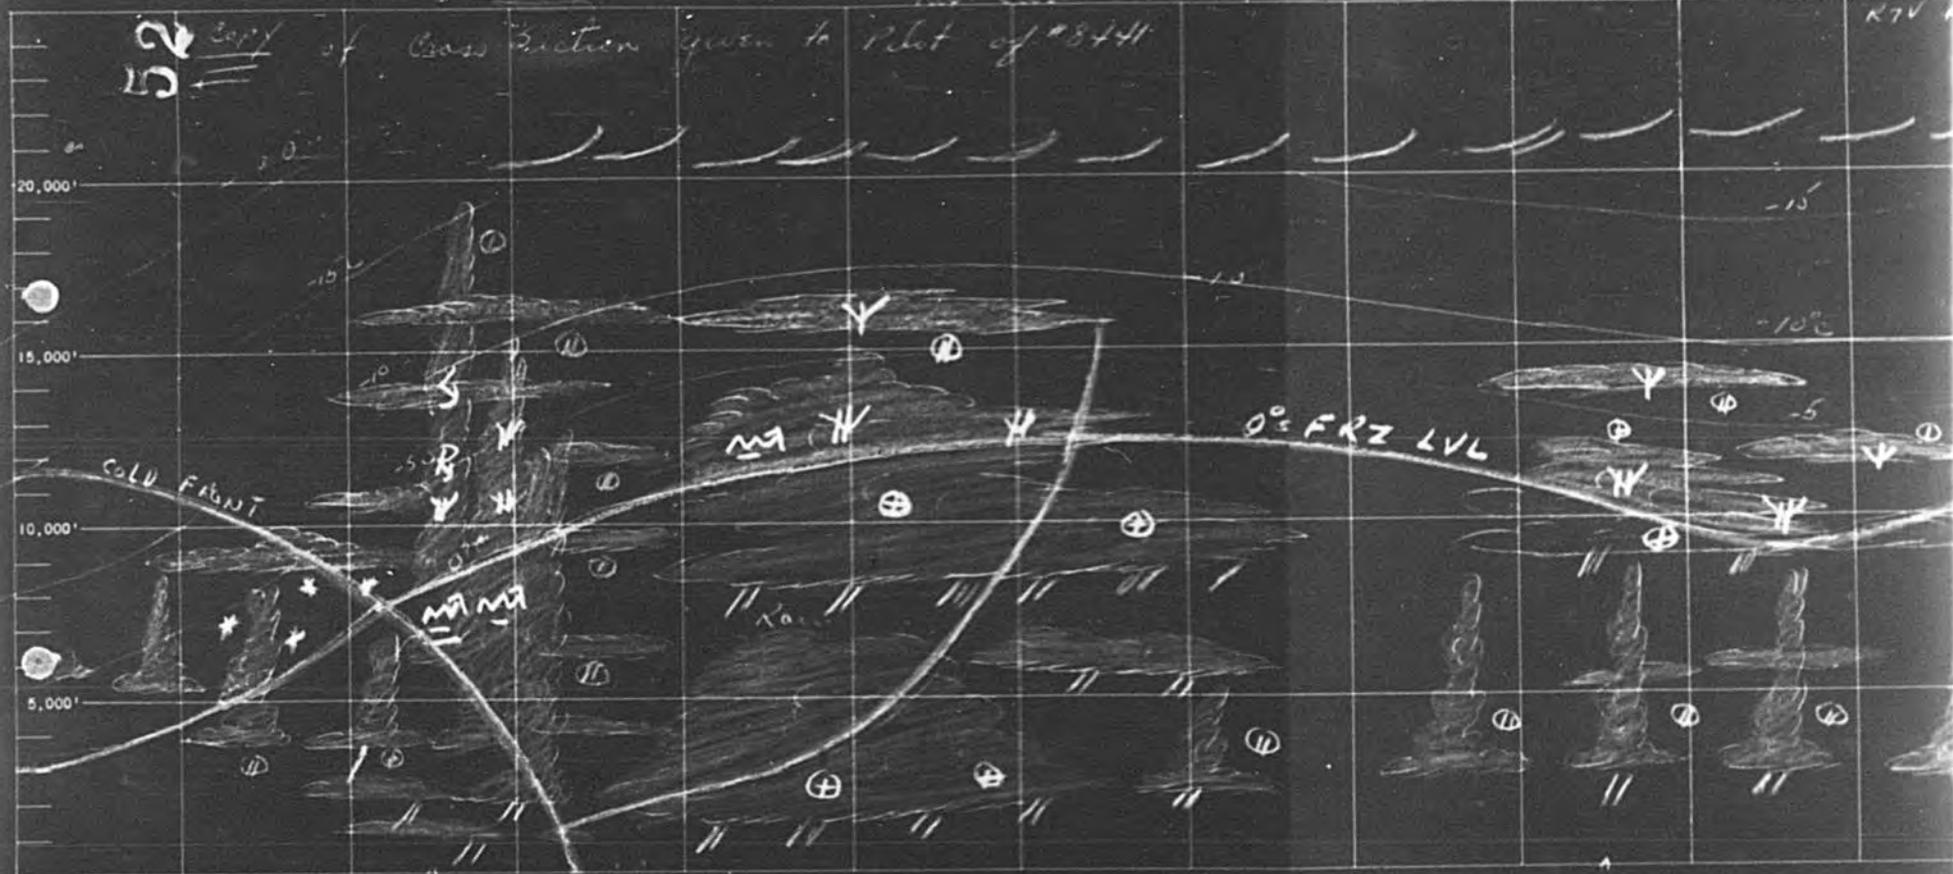
VERTICAL CROSS SECTION

FROM PAK TO LAKES TRACK 20. + 4. 31/013. 2 E.T.D. 31/013. 2
the line
46. 3100 A GP
